# Manhole Inspection Summary

Manhole # S21GG2009MH

**Location** Address: **1107 HARRITON RD**

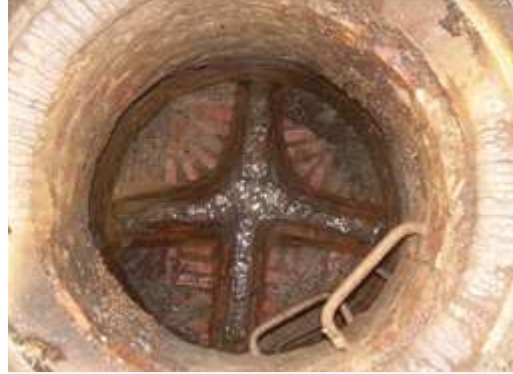
Top View

Frame offset. Corroded steps. Bench debris.

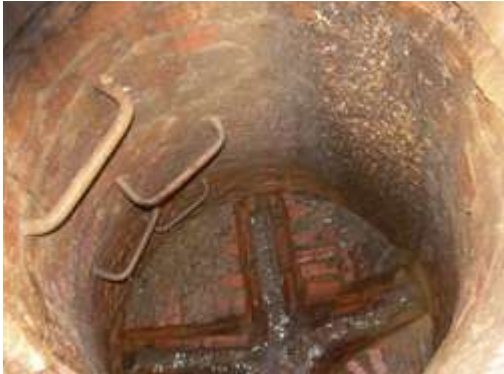
Defect

Adjustment deterioration and infiltration.

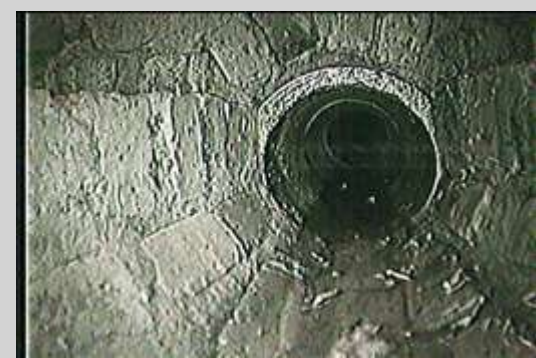
### 8 in. Circular Gravity Sewer Pipe Out @ 12 O'Clock

Infiltration: **Evidence** Pipe Seal Cond: **Cracked**

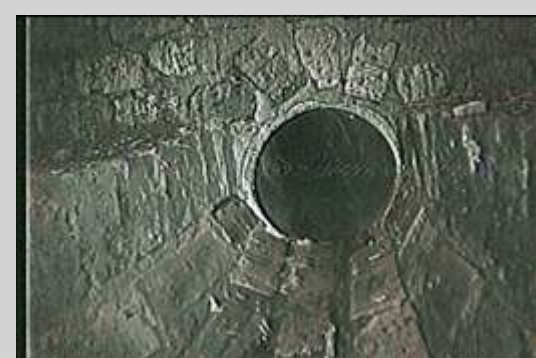
### 8 in. Circular Gravity Sewer Pipe In @ 3 O'Clock

Infiltration: **Evidence** Pipe Seal Cond: **Cracked**

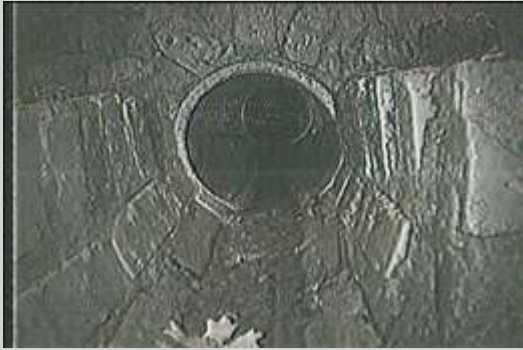
Pipe In @ 6 O'Clock

Channel deterioration.

Infiltration: **Evidence** Pipe Seal Cond: **Cracked**

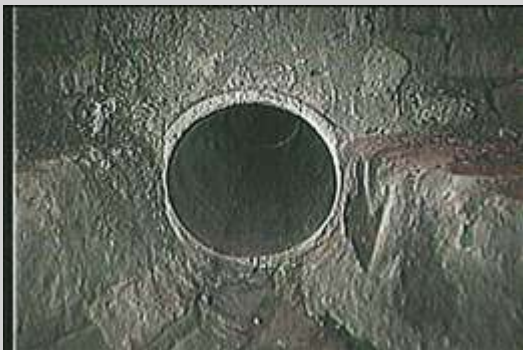
Pipe In @ 9 O'Clock

Infiltration: **Evidence** Pipe Seal Cond: **Cracked**
